## PRESS RELEASE

Subject line: Analyzing earthquake damage in developing countries

(Toyohashi, Japan, 24 September 2014) Shaking table experiments performed by Toyohashi Tech researchers shed light on structural mechanisms responsible for the collapse of unreinforced masonry buildings during earthquakes in developing countries.

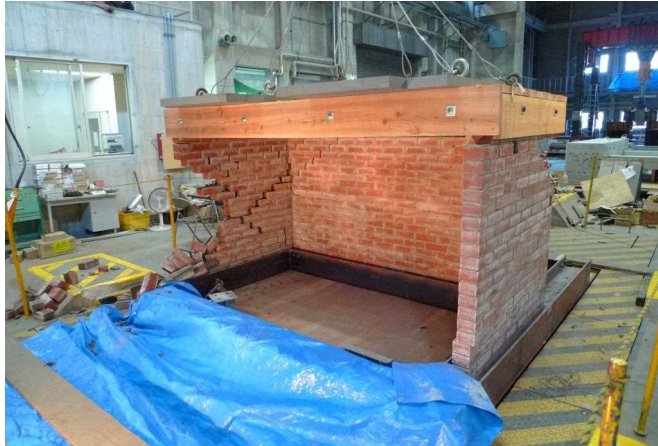
Caption: Collapse of the masonry wall specimen with a wooden slab.

In order to represent typical masonry houses in rural areas in Peru, two specimens were constructed and tested on the shaking table. Both specimens had three walls combined together in the form of a C-shape. One specimen had no floor slab and another one had a wooden floor slab.

From the vibration tests, the generation pattern of cracks and the collapse mechanism were examined. Whereas the first specimen showed the out-of-plane flexural failure mechanism, the other specimen exhibited in-plane shear failure mechanism. This difference is presumed to be due to the restraint effect by the floor diaphragm.
